Hydrological Impact of a Tidal Regulator on Land and on Water in a Tropical Estuary of Kerala, India

E. Shaji

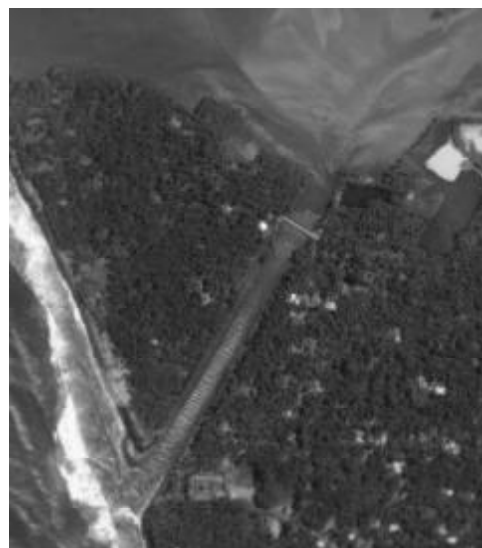
Fig. 1b: Digital globe satellite imagery from Google Earth clearly shows the buildup of sediment shoals in the Paravaur estuary close to the tidal regulator at Pozhikkara in Kerala, India

which gets filled up gradually. During the months of November and December every year, high tide may continue for 12 hours per day. At that time large volumes of sand will be transported into the estuary. The sandy shoal that formed last year is clearly visible in Fig. 1b and 9. It is reported by the local people that one-third of the estuary has already been filled up. If this continues for another five years the Paravoor estuary will disappear by being filled up with sand, ultimately leading to flooding and submergence of the adjoining land during monsoon season. The bio-aquatic degradation is leading to ecological imbalances and threatening the economic well-being of the populace in the vicinity of the lake. Even the movement of boats is hindered by the sandy promontories in the lagoon. The regulator is a real threat to the lake and life, unless it is properly maintained.

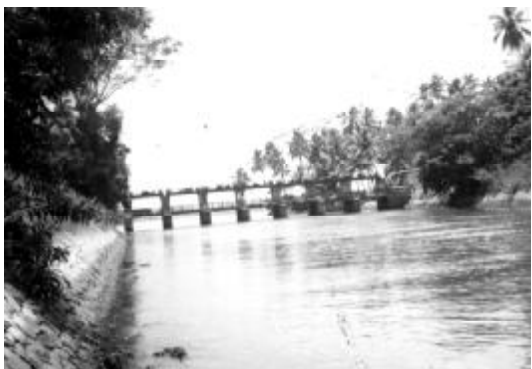
Fig. 8: The regulator without shutters enabling free flow of water in both directions: towards sea and towards estuary.

Salinity of the backwaters: Paravoor estuary was saline only at the time of high tides during summer, but usually it got neutralised during rainy season. During 1985 the performance of the shutters deteriorated and collapsed by 1990. Ultimately the shutters were unable to stop the sea water ingress into the estuary, thus, increasing the salinity of the estuary many-fold.

Filling up of the Paravoor Kayal: The collapsed spillway shutter has been defunct since 1990, and by the end of 1999 the irrigation department removed the shutter for repair or fitting a new one. Now the regulator is without shutters as shown in Fig. 8. If the shutter is closed, the natural sand bar will once again be created along the coast by wave motion and the sand will not enter the estuary. However, once the shutter is dysfunctional the sea sand gets transported to the interior of the estuary,

Restoration: In the water quality-compromised island areas rainwater harvesting should be practised. The extraction of groundwater from the wells should be minimised, especially during summer months to prevent further salinity ingress. The shutters of the spillway should be refitted immediately to avoid further damage to the surrounding area and to the ecosystem of the estuary. Laying large diameter concrete pipes beneath the coastal road will help drain the floodwater during monsoon and protect the natural sand bar. The shutter operations should be monitored by an expert and should be based on scientific studies of hydrogeology and sediment transport rather than on the whims and fancies of government officials or the now defunct farmers. Any developmental project along or near the coast should be scrutinised thoroughly and environmental impact assessment carried out to find the feasibility of the project, prior to implementation. For sustainable development, identification and integration of environmental objectives, formulation of an operational strategy and provision of adequate technical, financial and institutional support are very vital.

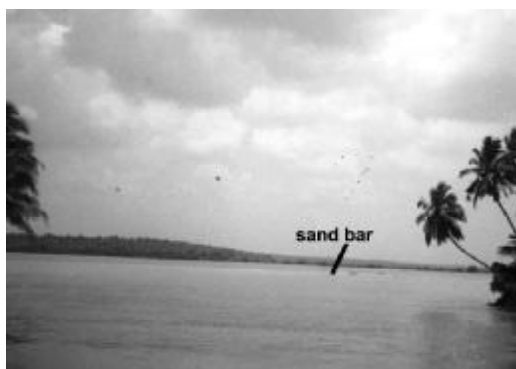
Fig. 9: Filling up of Paravoor estuary with sea sand, arrow shows the elongated sand bar or shoal.
